## ACOUSTICAL PERFORMANCE TEST REPORT

ASTM E90 SOUND TRANSMISSION LOSS TESTING ON A  
PRIMEALUX HORIZONTAL PRIVACY PLUS FENCE

S8904.01-113-11-R0

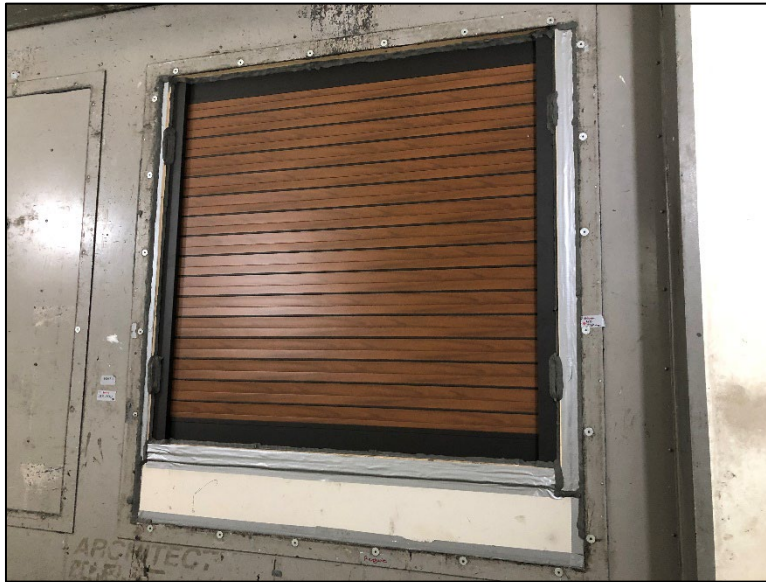
Photo No. 1

Receive Room View of Installed Test Specimen

The test specimen included fifteen interlocking horizontal slats. Each slat was 68-7/8" wide by 7/8" high by 7/8" thick. An H rail was placed between each slat to interlock them. The aluminum horizontal slats were 68-7/8" wide by 4" high by 7/8" thick and were filled with foam.

There was a hollow horizontal top and bottom starter rail that was 4-3/4" wide by 68-7/8" high by 7/8" thick. There were two end posts at both sides of the fence that were 3-1/8" wide by 72" high by 3-1/8" thick. The overall size of the fence was 75-1/4" wide by 72" high which included the posts.

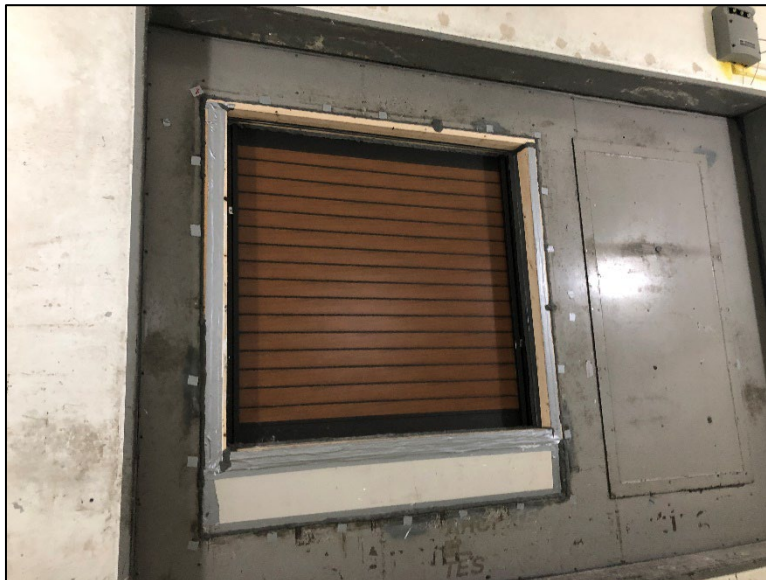
Photo No. 2

Source Room View of Installed Test Specimen
